Technical Memorandum
Metacomet Country Club
East Providence, Rhode Island

*Archaeological Monitoring of Geotechnical
Borings*

March 25, 2024

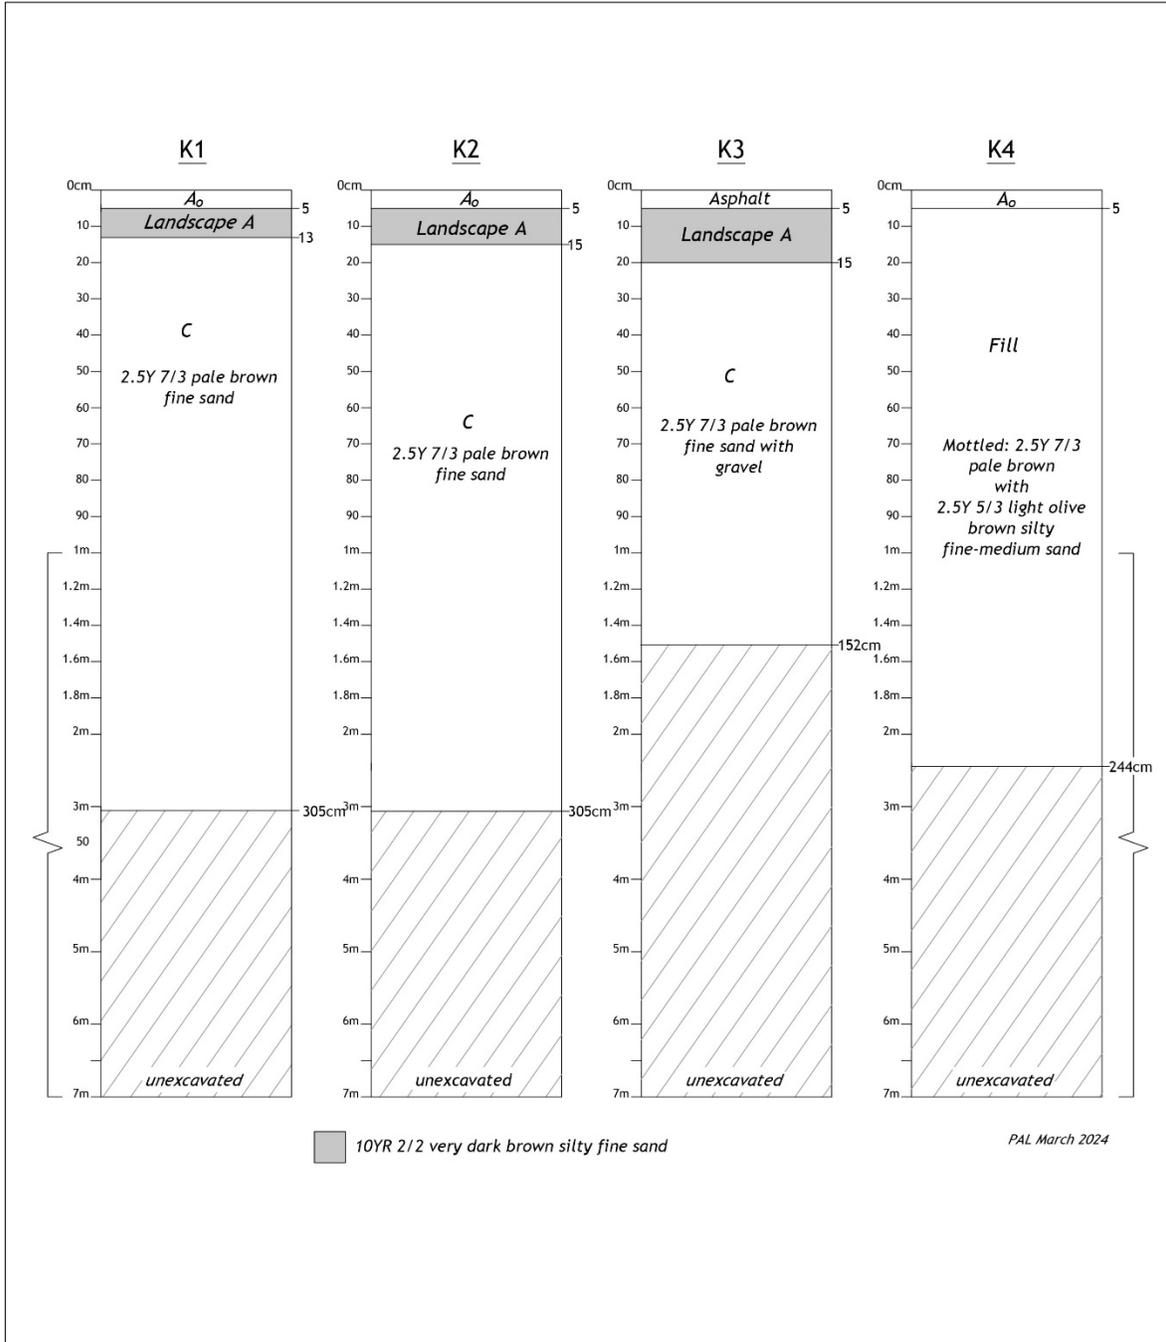
Figure 3a. Representative soil profiles from geotechnical borings/test pits within the western section of Metacomet Country Club Project Area

Soil borings conducted along the western edge of the project area include K1 through K8 (with K6 being the only test pit). The soils documented in K1, K2, and K3 which were placed within the northwest corner of the Project Area, showed C horizon soils under a landscaped topsoil. A similar profile was documented at K6, K7, and K8. The soil profile K4 showed modern fill to a depth of more than 2 meters (m). No further testing or monitoring is recommended in the area surrounding these borings.

Intact soils were documented in K5 located along the absolute western edge of the Project Area in the southwest corner. The core showed an intact soil sequence starting at the surface, including an A topsoil of dark brown (10YR 3/3) silty fine sand down to 15 cm below surface (cmbs) atop a B1 of dark yellow brown (10YR 4/6) silty fine sand down to around 32 cmbs. The B2 was a yellow brown (10YR 5.6) silty fine sand which transitioned to a pale brown (2.5Y 7/3) fine sand C soil around 54 cmbs. K6 is located along the absolute southern edge of the Project Area in the southwest corner, and

displayed intact wetland soil of light grey (2.5Y 6/1) silty sand beneath 50 cm of disturbed/landscaped topsoil. Shovel testing is recommended for the areas immediately surrounding K5.

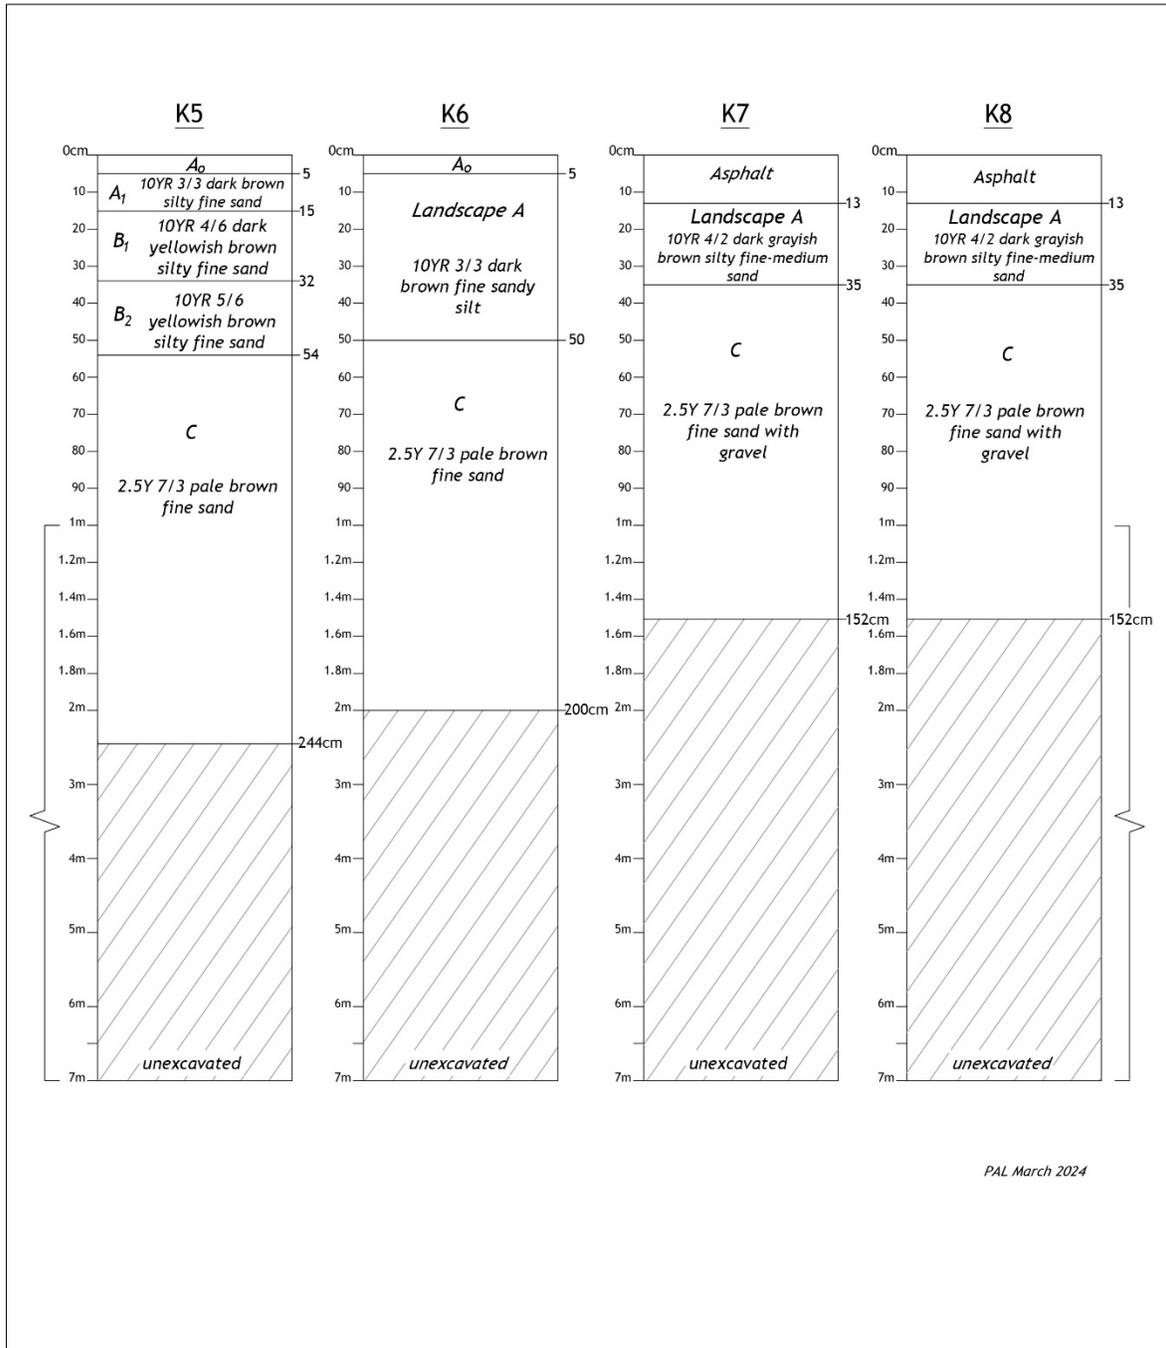
Figure 3b. Representative soil profiles from geotechnical borings/test pits within the western section of Metacomet Country Club Project Area

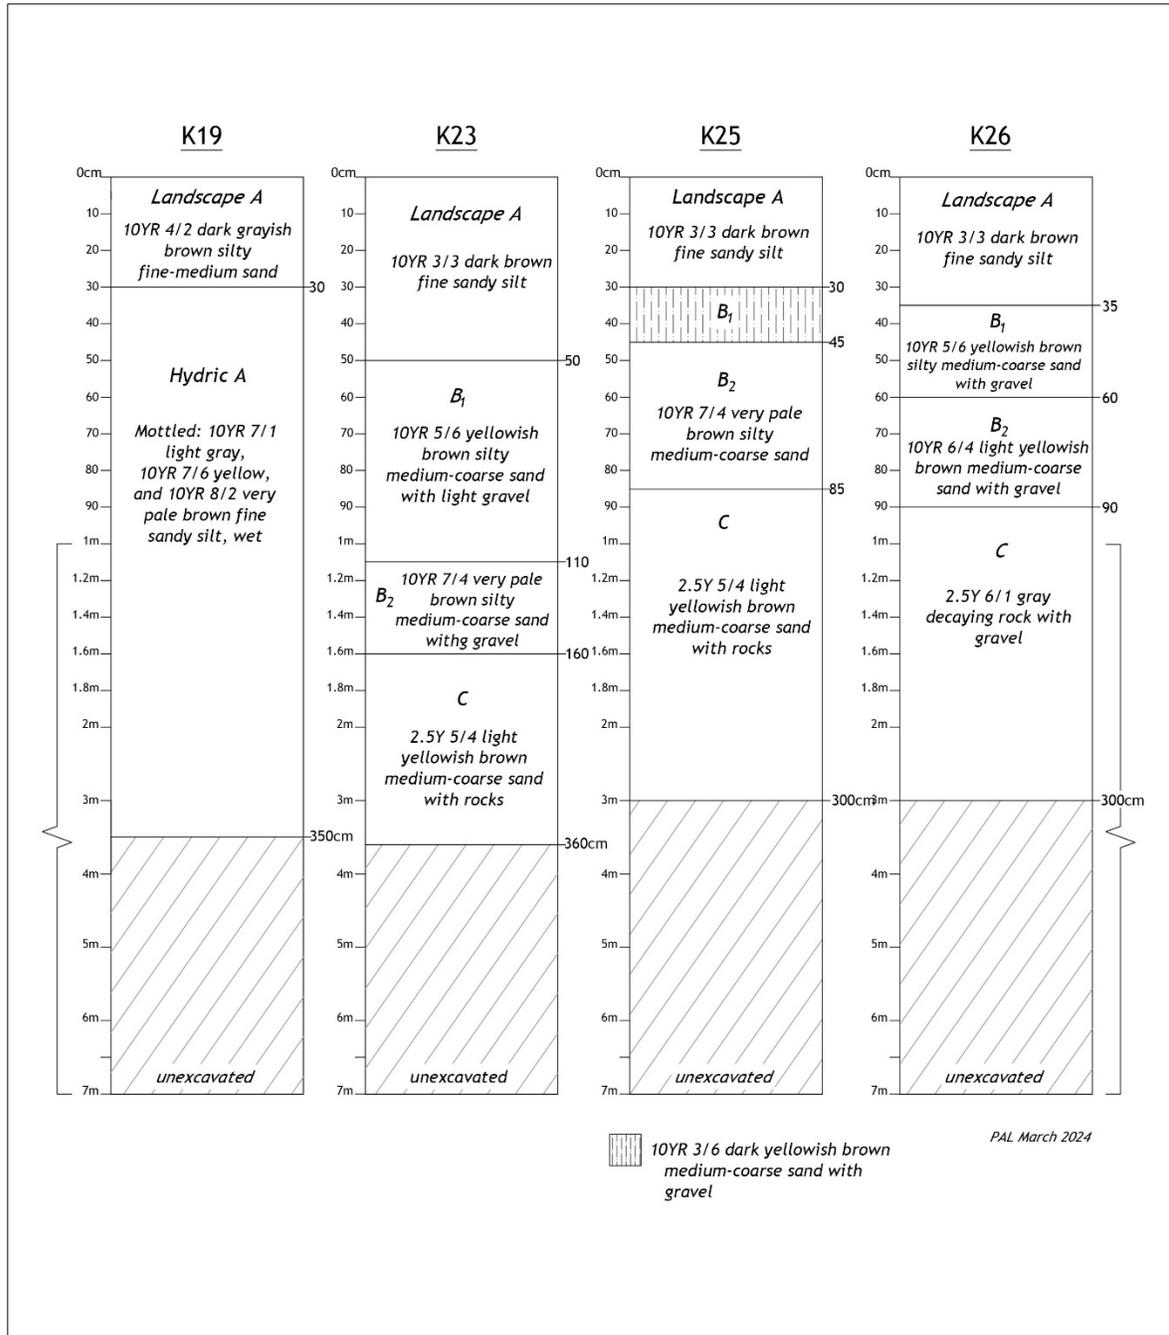
Figure 3c. Representative soil profiles from geotechnical borings/test pits within the eastern section of Metacomet Country Club Project Area

Test pits conducted along the eastern edge of the project include K23, K25, and K26. These three test pits are located in the southeastern corner of the Project Area. The soil profiles between these three pits were comparable, with an intact B1 subsoil of yellow brown (10YE 3/6) silty medium to coarse sand beneath 30 to 50 cm of landscaped topsoil. Two soil anomalies were encountered within K25. Feature 1, at 30 cmbs, was identified as a very dark grey brown (10YR 3/2) circular stain, approximately 30 cm in diameter with charcoal flecking and small amounts of shell (Photo 1). Feature 2 was encountered at 50 cmbs and was comparable to Feature 1 but slightly larger in diameter, around 50 cm, and also had charcoal flecking and small amounts of shell (Photo 2). These features appear to be small refuse pits after photographing they were reburied to avoid further impact. Shovel testing is recommended for the areas surrounding K23, K25, and K26.

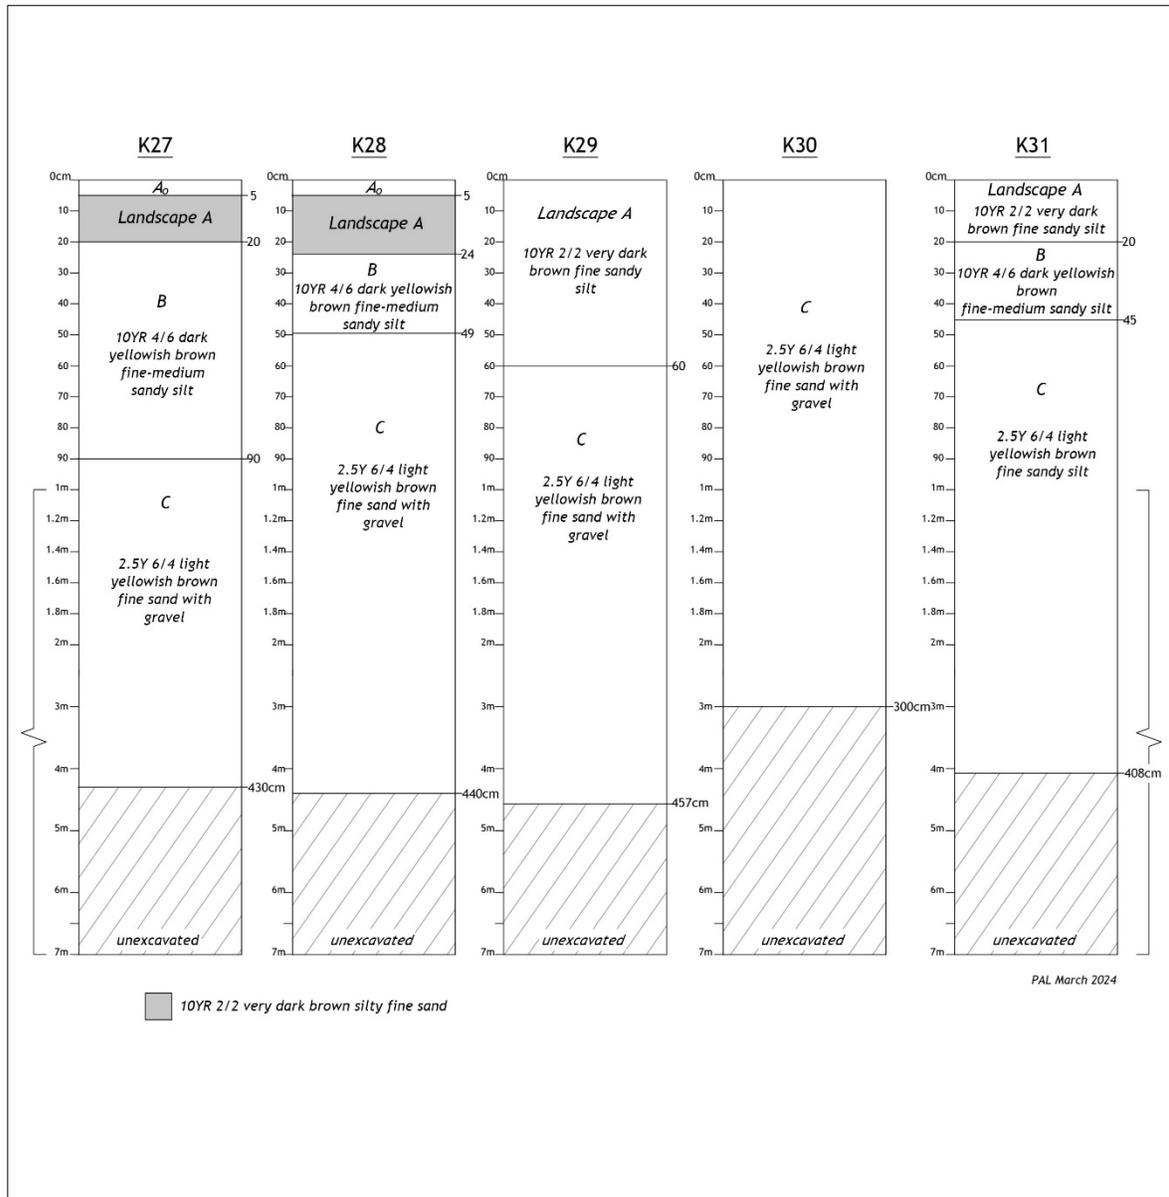
Figure 3d. Representative soil profiles from geotechnical borings/test pits within the central section of the Metacomet Country Club Project Area

A transect of six borings (K27 through K31) and one isolated test pit (K19) was monitored by PAL in the central portion of the Project Area. The soil profile documented at K27 included intact B1 subsoil of dark yellow brown (10YR 4/6) fine sandy silt beneath 90 cm of landscaped topsoil. Any further soil grading or any activity that would involve subsurface disturbance at this location is recommended to be monitored. The soil profiles documented at K28 and K31 were similar to the one observed at K27 but with intact subsoil closer to the surface, at around 45 cmbs. Intact wetland soil of light grey (10YR 7/1) silty fine sand was documented beneath 30 cm of landscaped topsoil at K19. Shovel testing is recommended for the areas immediately surrounding these locations before any further disturbance.

Sterile C Horizon beneath 240 cm of disturbed/landscaped topsoil made up the profile of K29. The soil profile at K30 was entirely sterile parent material. No further testing or monitoring is recommended in the area surrounding these borings.

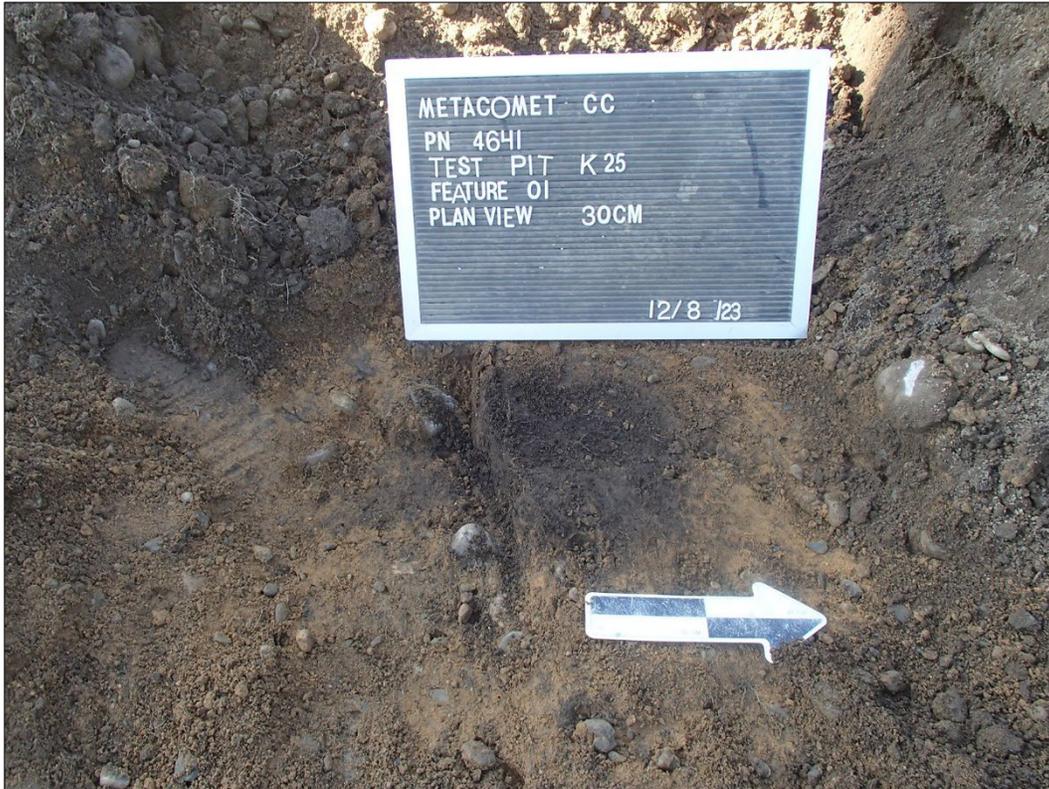
Photo 1. Feature 1 from Test pit K25.

Except for the soils at K29 and K30, all the borings monitored in the center of the Project Area (K19, K27, K28, and K31) had intact soil beneath landscaped topsoil. Shovel testing is recommended for these areas if they are to be disturbed by soil grading activities. Test pits K23, K25, and K26 in the southeastern corner of the Project Area also had intact subsoil beneath landscaped topsoil. Two soil anomalies that contained charcoal and shell were encountered in one test pit (K25). Shovel testing is recommended for these areas before any further disturbance.

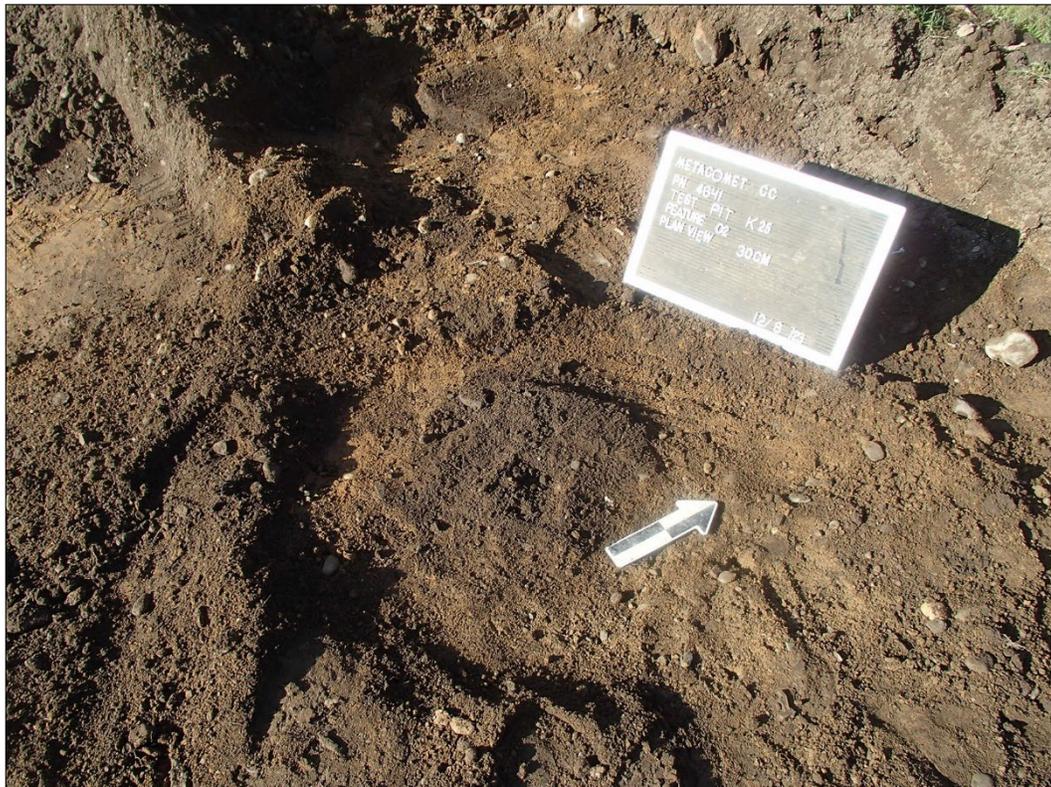
Photo 2. Feature 2 from test pit K25.
